United States General Accounting Office

July 1994

NAVY SUPPLY

Improved Material Management Can Reduce Shipyard Costs

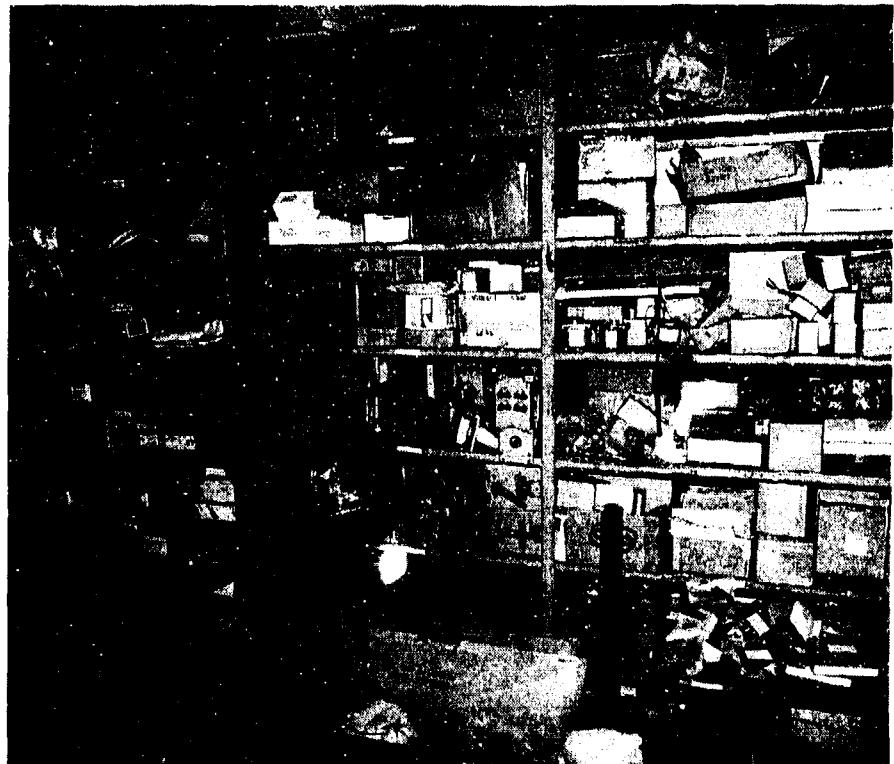
In the electronics shop's communications work center, the supervisor did not keep a list of goldpile material. However, we observed about 15 large cabinets containing goldpile material. In about 20 minutes we recorded the stock numbers for 28 items and counted the on-hand quantities. The cost of this material was over \$29,000.

**Figure 3.1: Unrecorded Material in
Norfolk's Fire Control Work Center**

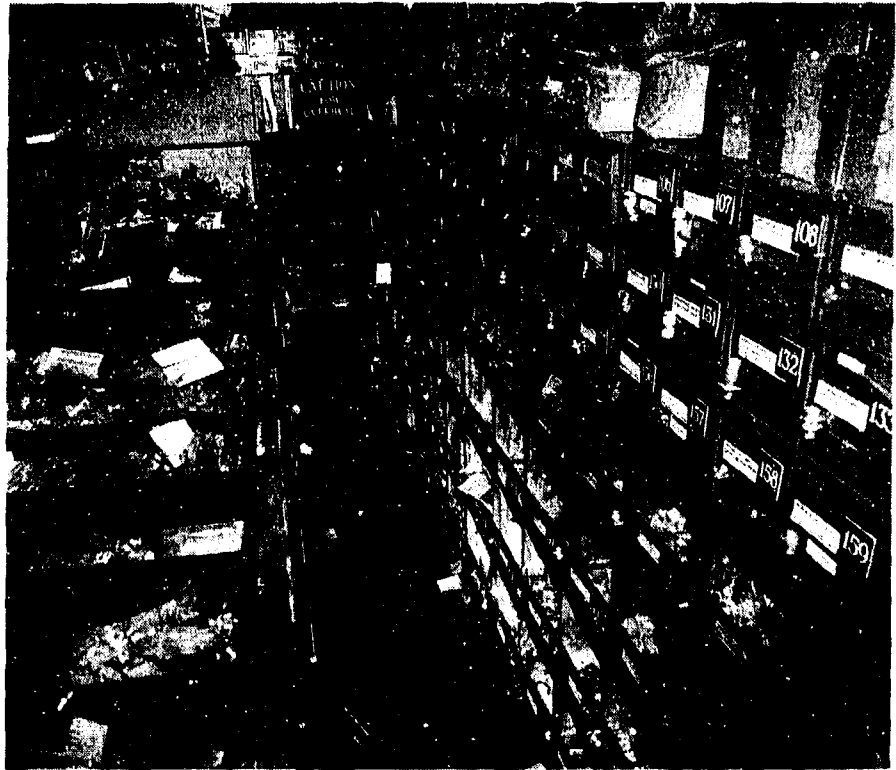
Figure 3.2: Unrecorded Material in
Norfolk's Plug Work Center
